**Investigation
Line of Duty Injuries
On October 25, 2009
Kissimmee Fire Department
Kissimmee, Florida**

**Safety Investigation Report
Prepared by the Safety Section
Bureau of Fire Standards and Training
Florida Division of State Fire Marshal
Florida Department of Financial Services**

Incident #09-0007597
October 25, 2009
Villa Del Sol Apartments
4103 Tropical Isle Blvd.
Kissimmee, Florida

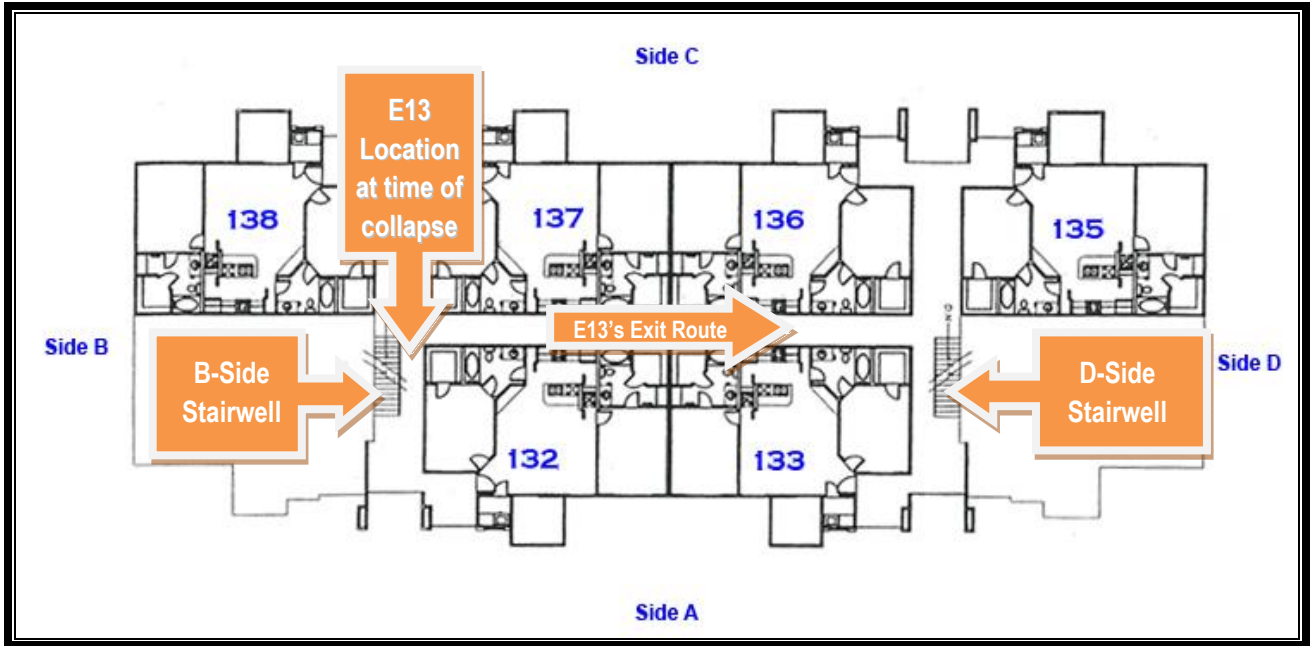
Figure 1 – 3rd Floor Diagram

Both the Lieutenant and the Firefighter from Engine 13 state conditions on the third floor landing were good, no smoke and very little fire was visible. A small hole was breached in the ceiling of the third floor landing by the Lieutenant and no smoke or fire was found. The Lieutenant reported he could see some heat via the thermal imaging camera up near the dormer area on Side-A of the building. The Lieutenant reported a small hole opening up in the wall of the dormer area several feet in front of them where a small amount of flames escaped indicating fire was coming up from below in the exterior wall (picture 3). The Lieutenant instructed the Firefighter to don his SCBA mask and was in the process of doing the same when they became engulfed in heat and flames (pictures 5, 6 and 7). The time of this occurrence was approximately 21:05. Command noticed a large volume of fire erupt from the third floor and inquired Engine 13 for a status check. About the same time, Engine 11 was in the process of assisting Rescue 13 in deploying a 2 ½ inch hose line and reports hearing a crash and seeing a large volume of fire erupt from the third floor landing. Engine 13's Lieutenant directs his Firefighter to follow him as he leads them both out of the area. They crawled to the breezeway that ran east and west through the interior of the building between the open stairwells and exited down the Side-C stairs (pictures 4 and 5) where they made contact with KPD officers and Engine 14's engineer (figure 1).

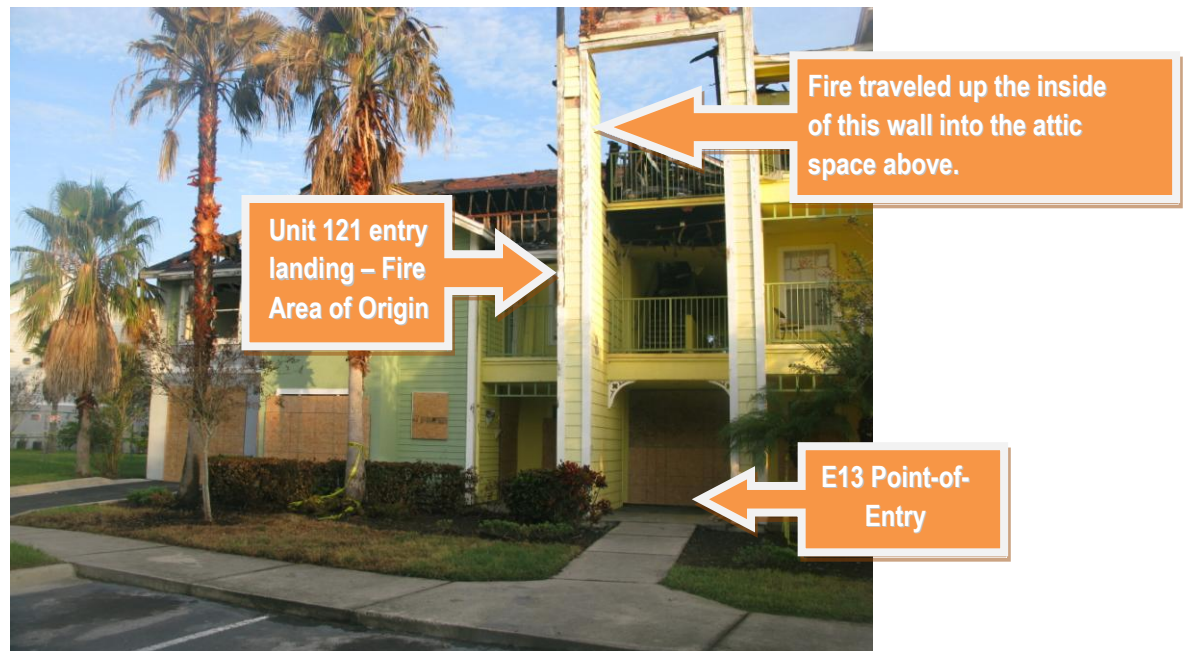
With the assistance of the State Fire Marshal's Office, it was later determined the fire started when residents attempted to eliminate a beehive on the entry landing ceiling of vacant unit # 121 on the 2nd floor by dousing it with an aerosol flammable liquid and igniting it (picture 8). They believed they had extinguished the ensuing fire and left the area, however flame had entered the space above the ledger and traveled unimpeded up the inside of an exterior wall into the roof where fire burned undetected for some period of time (pictures 3 and 8).

Picture 3 – Side A at E13's point-of-entry to B Side stairwell.

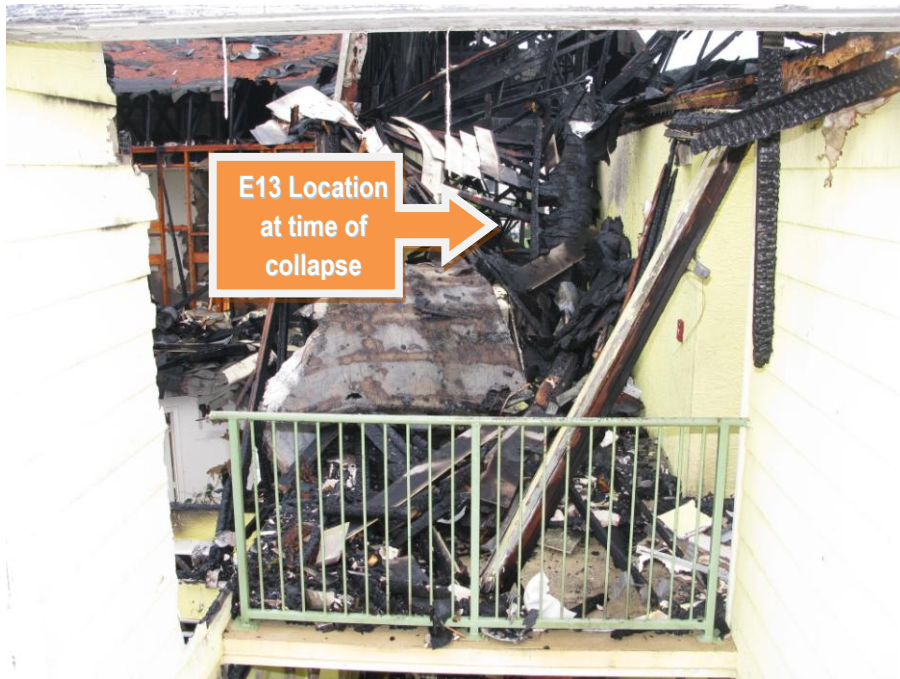
Operations has a face to face with Rescue 11 crew and directs them to the third floor to find the downed firefighter. Rescue 11 encounters a large amount of debris on the third floor landing (picture 6) but finds no firefighters however, they do find the helmet of the firefighter from Engine 13 in the breezeway on the third floor (picture 7). At 21:18 hours PAR is achieved on all units and firefighting efforts continue in a defensive mode until the fire is declared out. The injured firefighter from Engine 13 is transported via helicopter and the Lieutenant via rescue for treatment for their injuries. In addition to the units above, Kissimmee Rescues 12 and 14, Heavy Rescue 1, HSO 1 (Health & Safety Officer), and FD-2 (Deputy Chief) respond as well as Osceola Fire Rescue's Battalion 4, Engines 43 and 62, Rescue 42, Squad 42 (Special Operations Engine), Tower 72, and Med 6 (Safety Officer).

Picture 6 –View from Side A of 3rd floor landing on Side B stairwell.

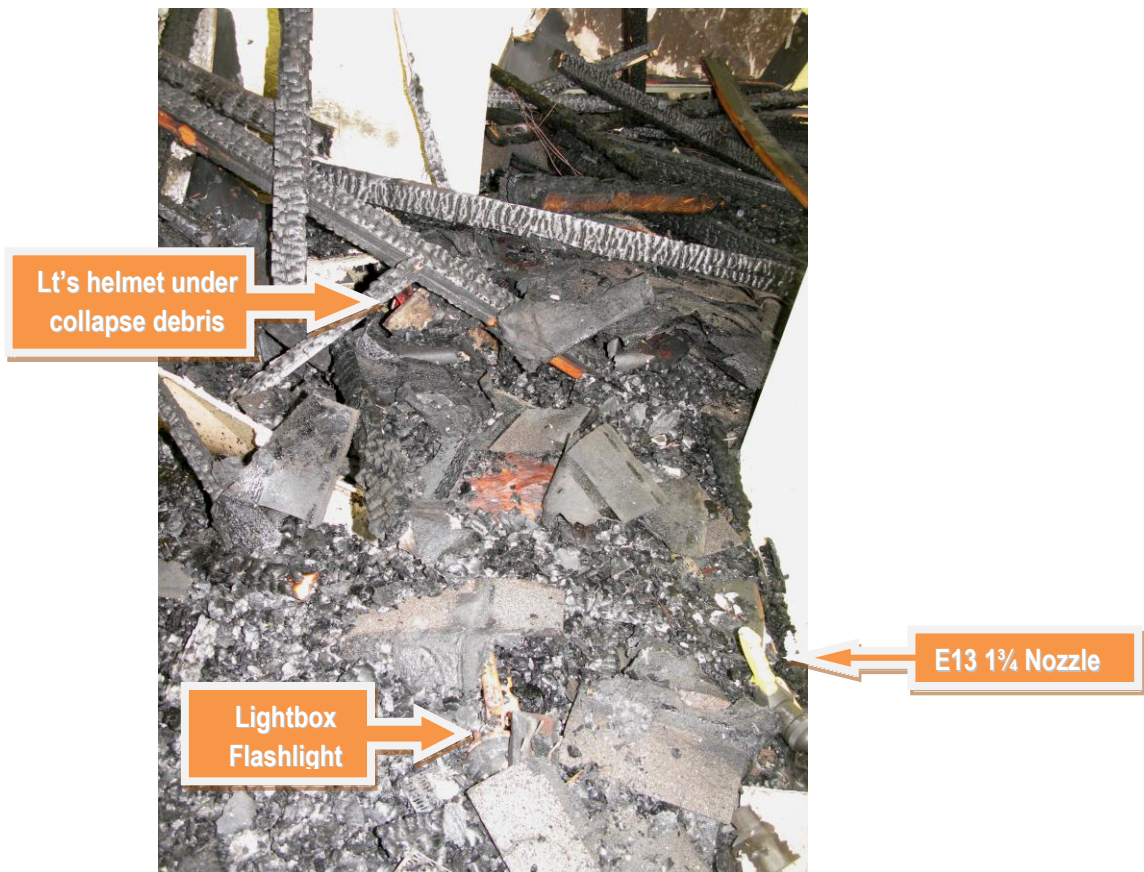
Picture 7 – View from 3rd Floor breezeway looking towards Side B stairwell landing – location of E13 when roof collapsed.

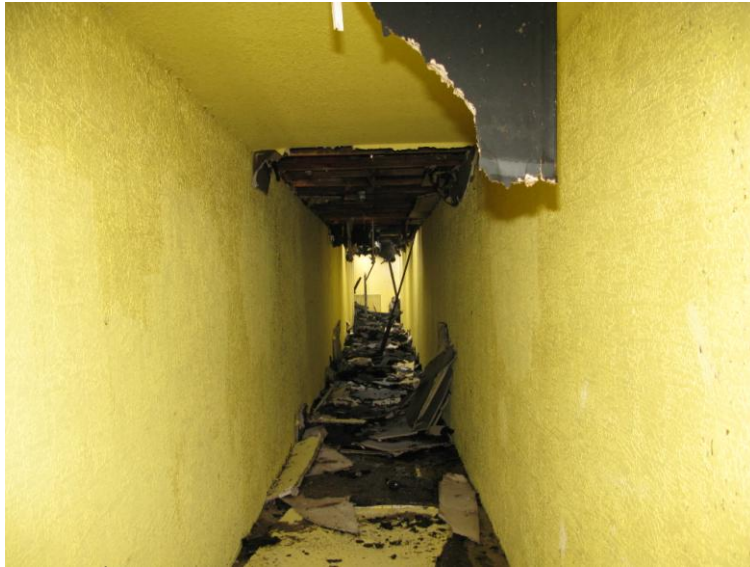
Picture 7 – View down 3rd floor breezeway from the Side D stairwell's landing looking towards Side B stairwell landing – E13's crew exited via this breezeway and down the Side D stairwell.

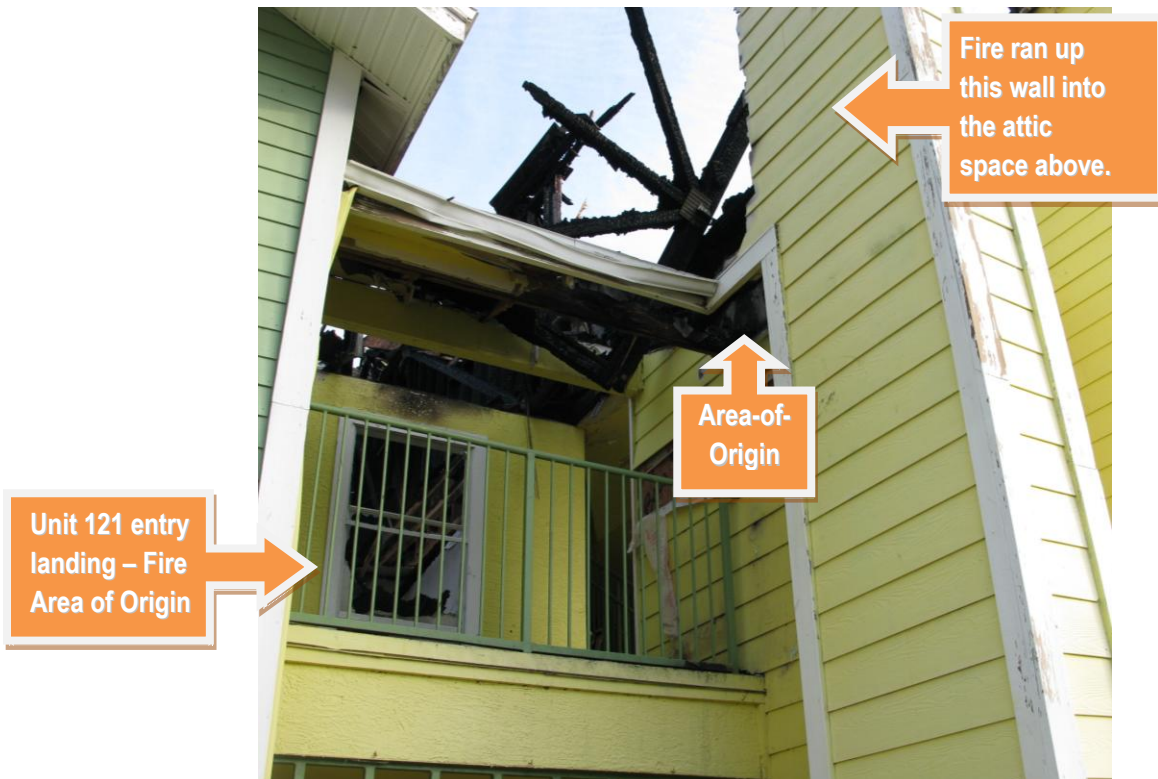
Picture 8 – Unit 121 2nd floor entry landing indicating the area of fire origin and route of travel up exterior wall to the attic above.
