New House Fire Hazard: Exploding Attic Stairs

08/28/2013

By Chris Kear and Jerry Knapp

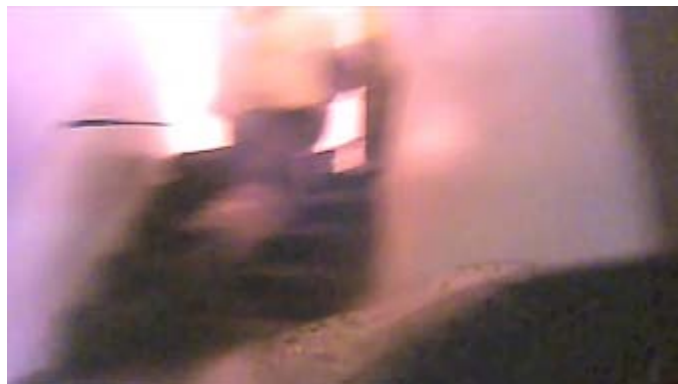
This screen shot shows the gas cylinder lodged in the wall on the left-hand side:

Firefighters behind me saw (and which was captured on video) what we later determined to be a gas spring from the pull-down stairs apparently become over-pressurized and launch from the pull-down attic stairs, shoot past and behind me, and imbed into the wall on the main staircase. A concrete fire wall behind the sheetrock stopped the cylinder and left it imbedded in the wall.
