**Investigation
Line of Duty Injuries
On October 25, 2009
Kissimmee Fire Department
Kissimmee, Florida**

**Safety Investigation Report
Prepared by the Safety Section
Bureau of Fire Standards and Training
Florida Division of State Fire Marshal
Florida Department of Financial Services**

Incident #09-0007597
October 25, 2009
Villa Del Sol Apartments
4103 Tropical Isle Blvd.
Kissimmee, Florida

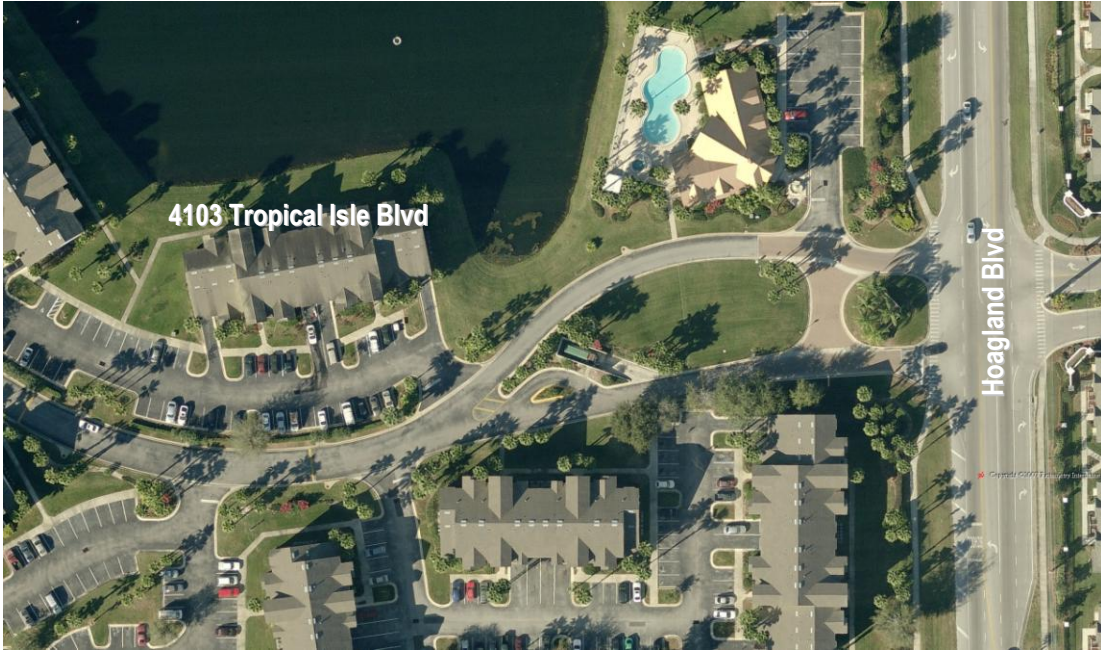
Picture 1 – Aerial Photo – 4103 Tropical Isle Blvd.

On October 25, 2009 at 20:54:33, a 911 call was received by Kissimmee Police/Fire Communications of a reported building fire at the Villa Del Sol apartment complex (picture 1) and after confirming the location, units were dispatched at 20:56:14. The initial caller reported smoke coming from the top of the building however, multiple calls were received reporting flames coming from the roof. As Battalion 1/B is preparing to respond a citizen walks up and reports “fire through the roof of the building” and he advises dispatch to request additional units from Osceola County Fire Rescue. Battalion 1/B was the first arriving fire department unit at 20:59:41 and reported “3 story apartment building, fire through the roof, please send out an admin page”. Arriving simultaneously with Battalion 1, the first arriving engine (Engine 13) was assigned to attack the fire. Engine 13 entered the B-side stairwell from Side-A (picture 2), stretching one 1¾ line up the stairwell to the third floor landing to attack the fire. The open stairwell was one of two in the building that each ran from Side-A to Side-C – this one closer to Side-B (picture 2). As Engine 13’s crew was deploying the hose line, dispatch advised that a wheel chair bound resident was still inside a first floor apartment and

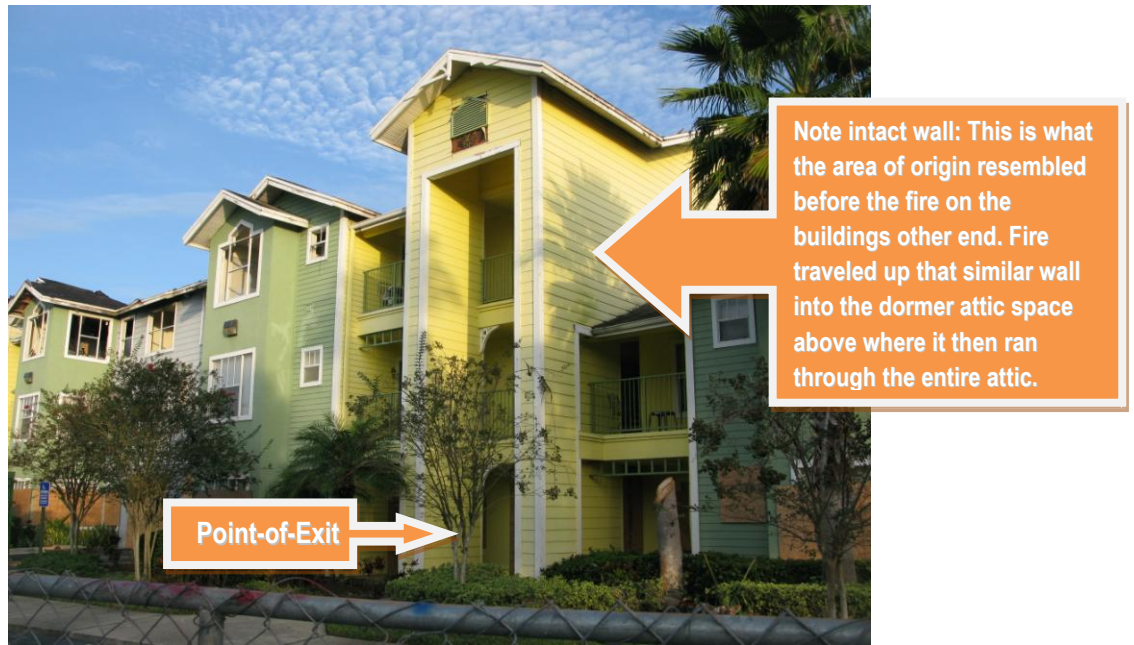
Picture 4 – Side A exit point of E13 from the D Side stairwell.

Both the Lieutenant and the Firefighter from Engine 13 state conditions on the third floor landing were good, no smoke and very little fire was visible. A small hole was breached in the ceiling of the third floor landing by the Lieutenant and no smoke or fire was found. The Lieutenant reported he could see some heat via the thermal imaging camera up near the dormer area on Side-A of the building. The Lieutenant reported a small hole opening up in the wall of the dormer area several feet in front of them where a small amount of flames escaped indicating fire was coming up from below in the exterior wall (picture 3). The Lieutenant instructed the Firefighter to don his SCBA mask and was in the process of doing the same when they became engulfed in heat and flames (pictures 5, 6 and 7). The time of this occurrence was approximately 21:05. Command noticed a large volume of fire erupt from the third floor and inquired Engine 13 for a status check. About the same time, Engine 11 was in the process of assisting Rescue 13 in deploying a 2 ½ inch hose line and reports hearing a crash and seeing a large volume of fire erupt from the third floor landing. Engine 13's Lieutenant directs his Firefighter to follow him as he leads them both out of the area. They crawled to the breezeway that ran east and west through the interior of the building between the open stairwells and exited down the Side-C stairs (pictures 4 and 5) where they made contact with KPD officers and Engine 14's engineer (figure 1).
